INDOOR AIR QUALITY ASSESSMENT

**Malden Fire Department, Maplewood Station
665 Salem Street
Malden, Massachusetts 02148**

Prepared by:
Massachusetts Department of Public Health
Center for Environmental Health
Emergency Response/Indoor Air Quality Program
January 2006

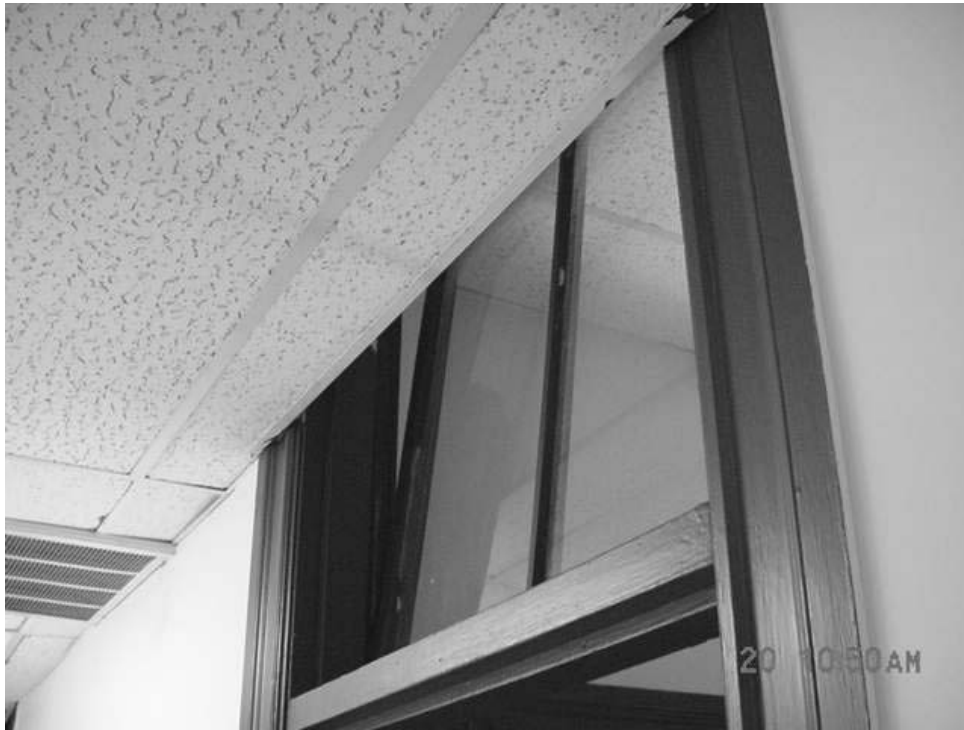
Picture 1

Transom over Bunkroom Door

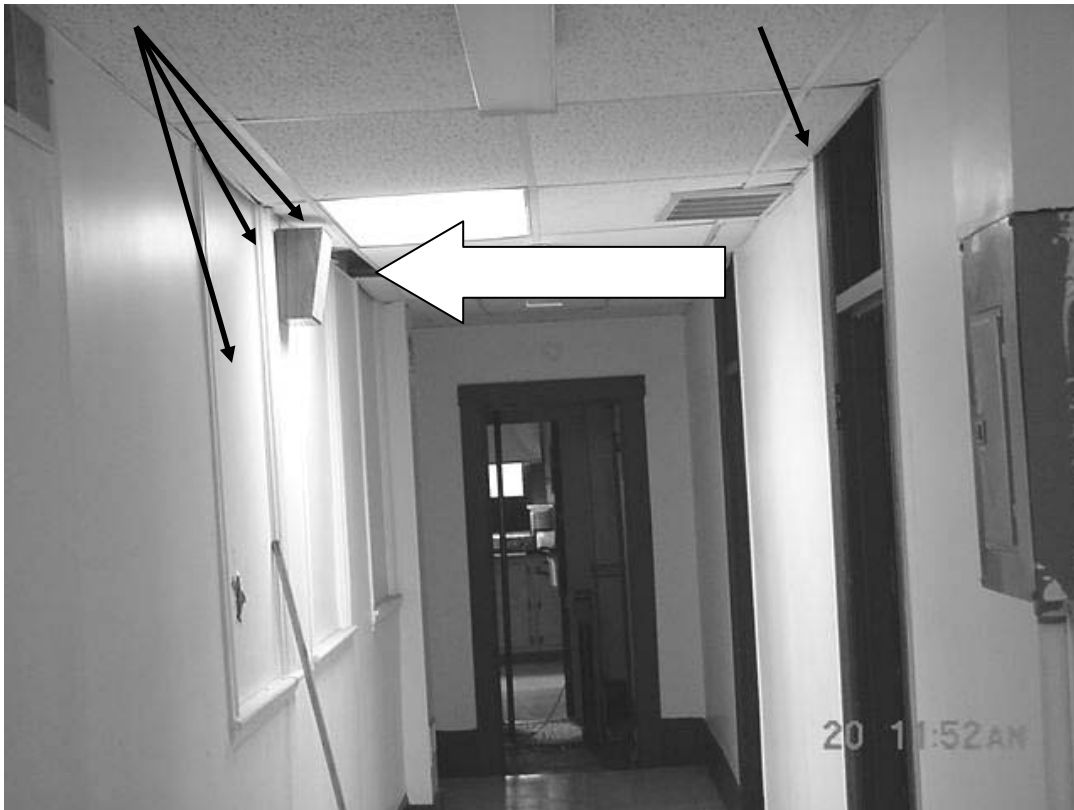
Picture 2

Windows (now sealed) and Transoms in Second Floor Hallway, Block Arrow Indicates Intended Airflow

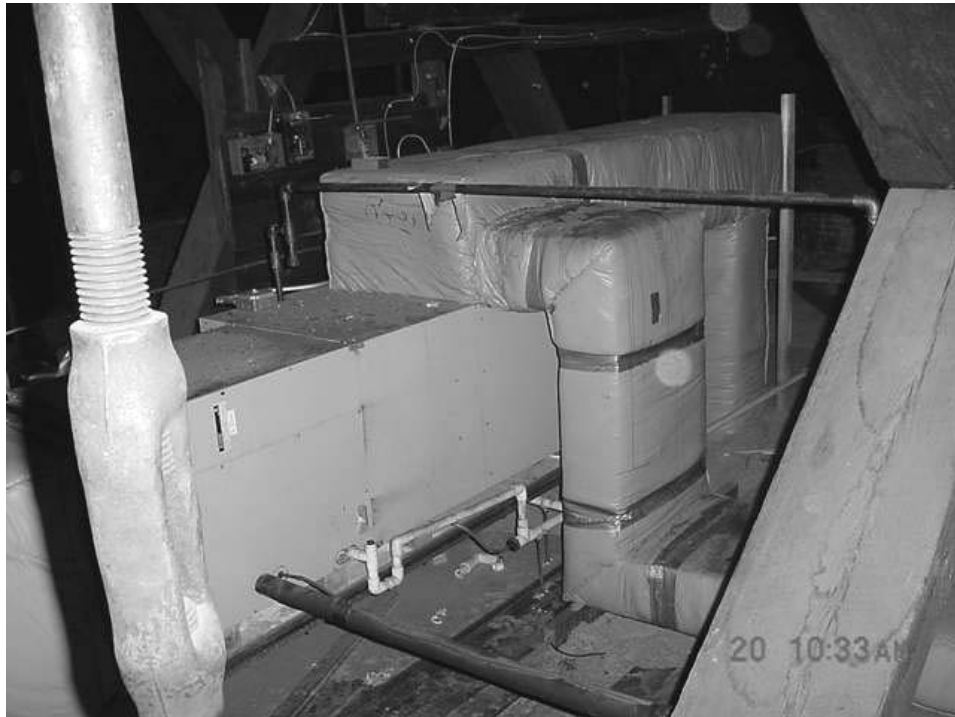
Picture 4

ventilation to introduce outside air. Heating and air conditioning is provided by air handling units (AHUs) located in the attic (Picture 4). The AHUs do not have the capacity to introduce outside air but *recirculate* air only. AHUs are ducted to wall mounted air diffusers (Picture 5). Ceiling mounted return vents in the hallways (Picture 6), draw air back to the AHUs via ductwork. These systems were operating during the assessment. MFD personnel could not confirm that a preventive maintenance program was in place for air handling equipment.

One of Two AHUs Located in the Attic

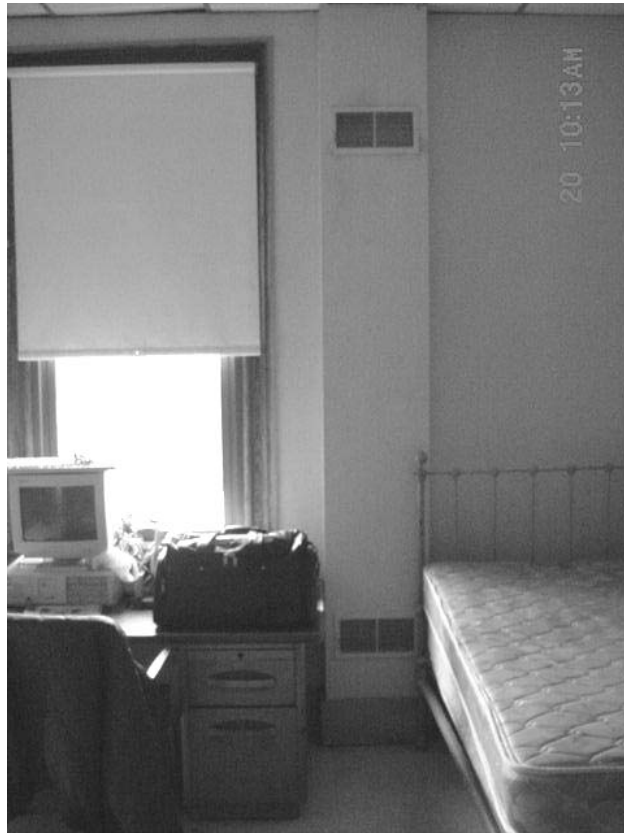
Picture 5

Wall-Mounted Supply Vents in Bedroom

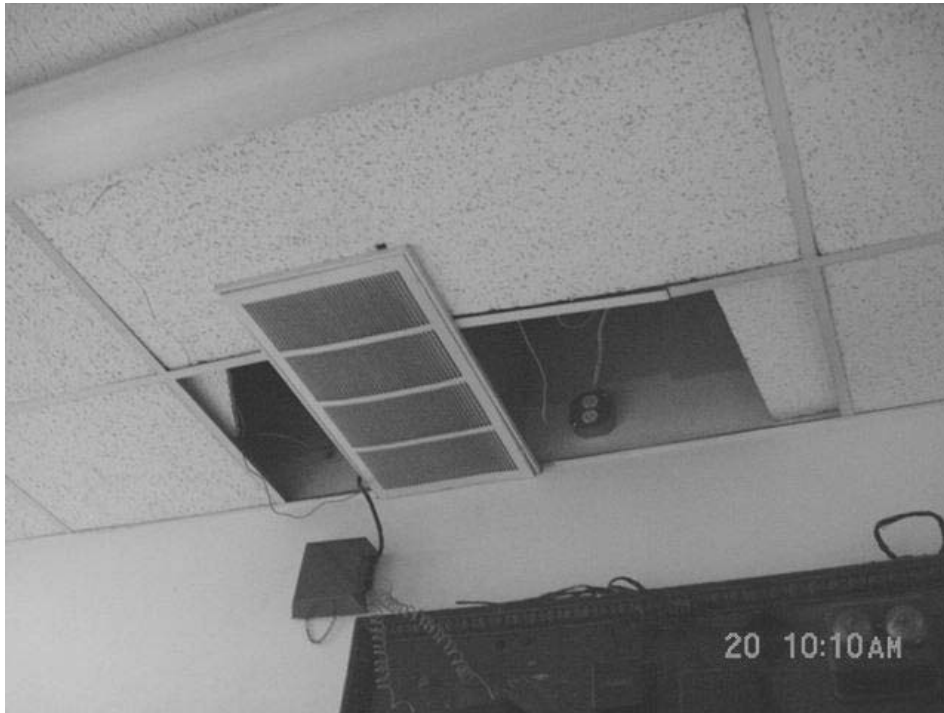
Picture 6

Ceiling-Mounted Return Vent in Hallway, Note Missing Tiles

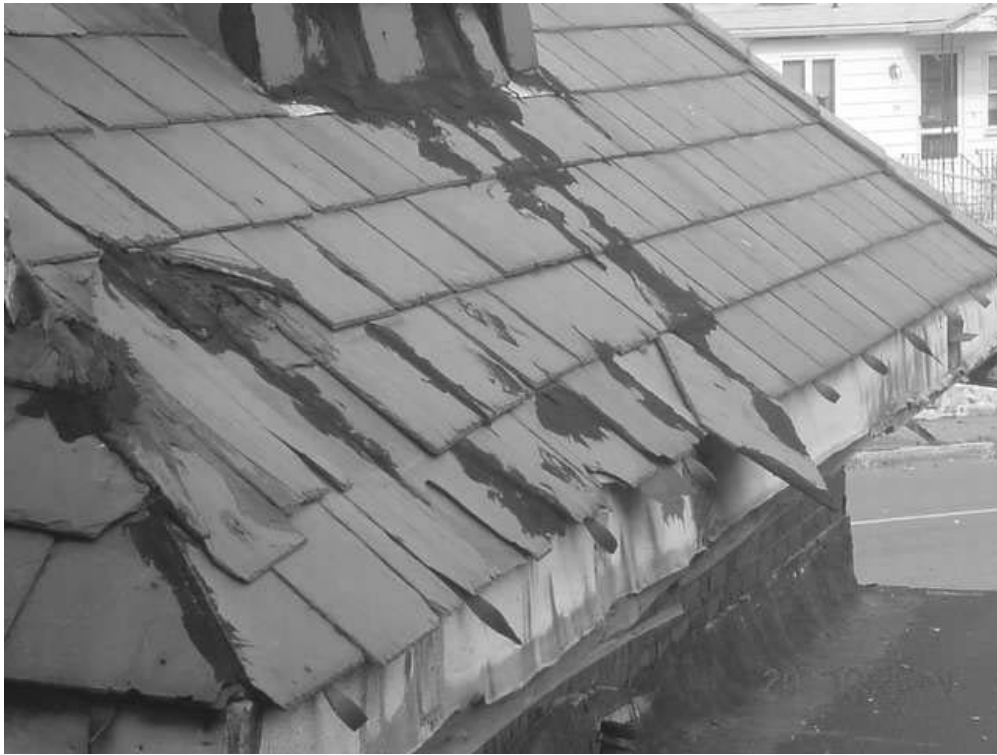
Picture 7

The building has reportedly experienced problems with water penetration, most notably from leaks through the slate roof (Picture 7). Water penetration throughout the building was evidenced by damaged/stained plaster, wood, ceiling tiles, peeling paint and efflorescence (Pictures 8 through 11). It was reported that roof repairs in several areas were

Slate Roof, Note Tar Indicating Patches and Damaged “Sliding” Shingles

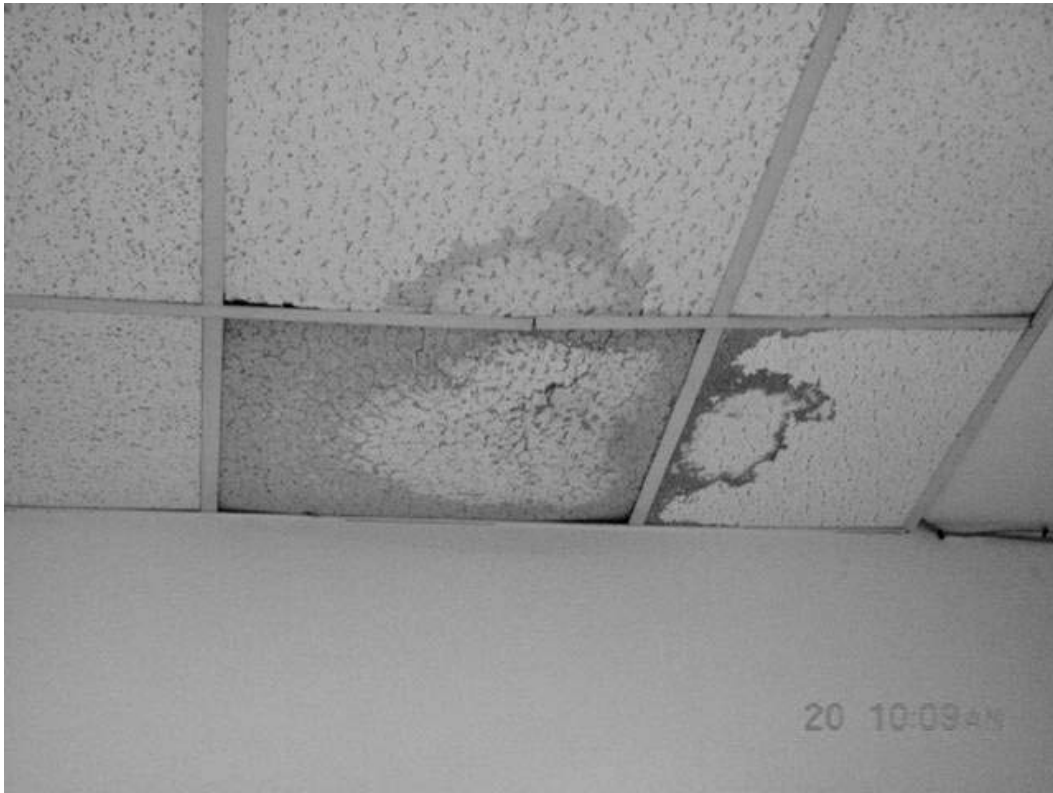
Picture 8

Water Damaged Ceiling Tiles in Second Floor Hallway

11. Replace/repair any remaining water-stained ceiling tiles and building materials. Examine the area above and around these areas for mold growth. Disinfect areas of water leaks with an appropriate antimicrobial.

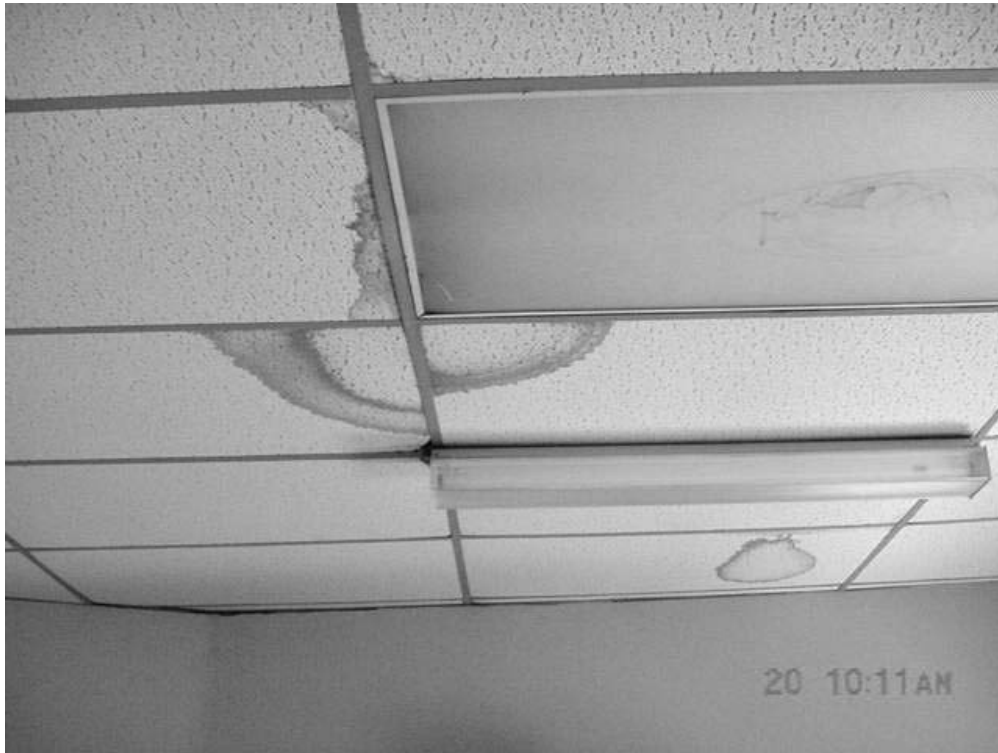
Picture 9

Water Damaged Ceiling Tiles in Bunkroom (the “Blue” Room)

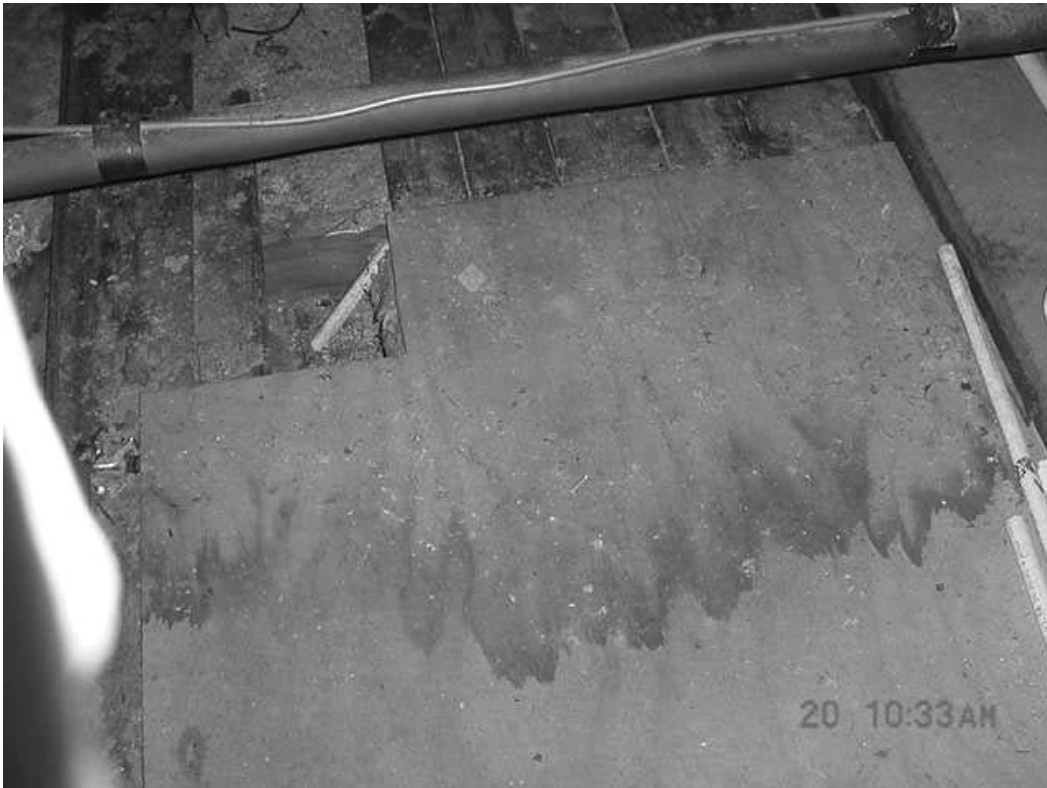
Picture 10

Water Stained Floorboard in Attic

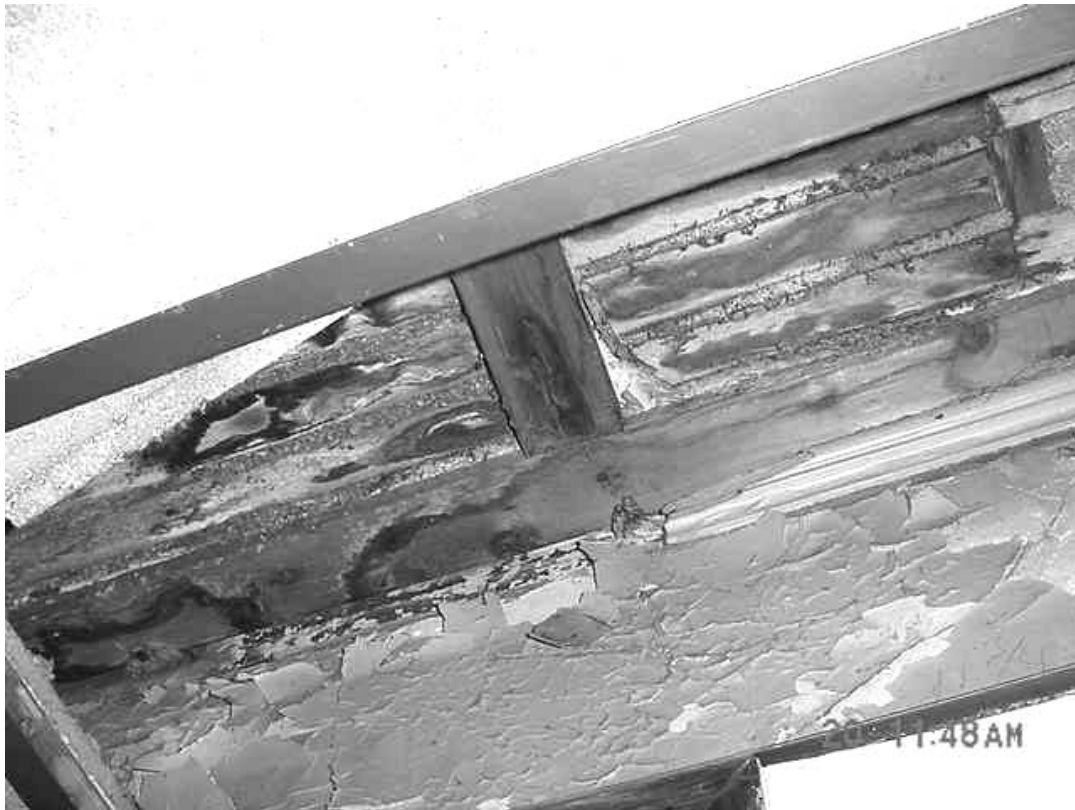
Picture 11

Water-damaged ceiling tiles can provide a source of mold and should be replaced after a water leak is discovered and repaired. Efflorescence is a characteristic sign of water damage to building materials such as brick or plaster, but it is not mold growth. As moisture penetrates and works its way through mortar around brick, water-soluble compounds dissolve, creating a solution. As the solution moves to the surface of the brick or mortar, water evaporates, leaving behind white, powdery mineral deposits. This condition indicates that water from the exterior has penetrated into the building.

**Water Damaged Ceiling Tiles, Plaster, Wood, Peeling Paint and Efflorescence
In Second Floor Bathroom**

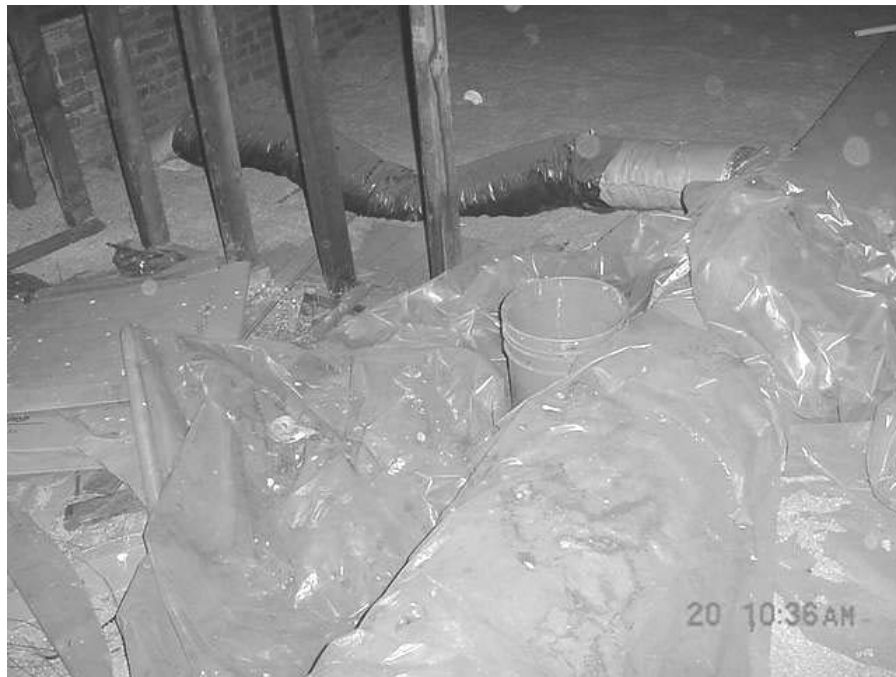
Picture 12

recently conducted. However, wet ceiling tiles were found in the patrol room and a bucket with standing water was observed in the attic (Picture 12), which indicates continuing leaks.

Bucket With Standing Water in Attic

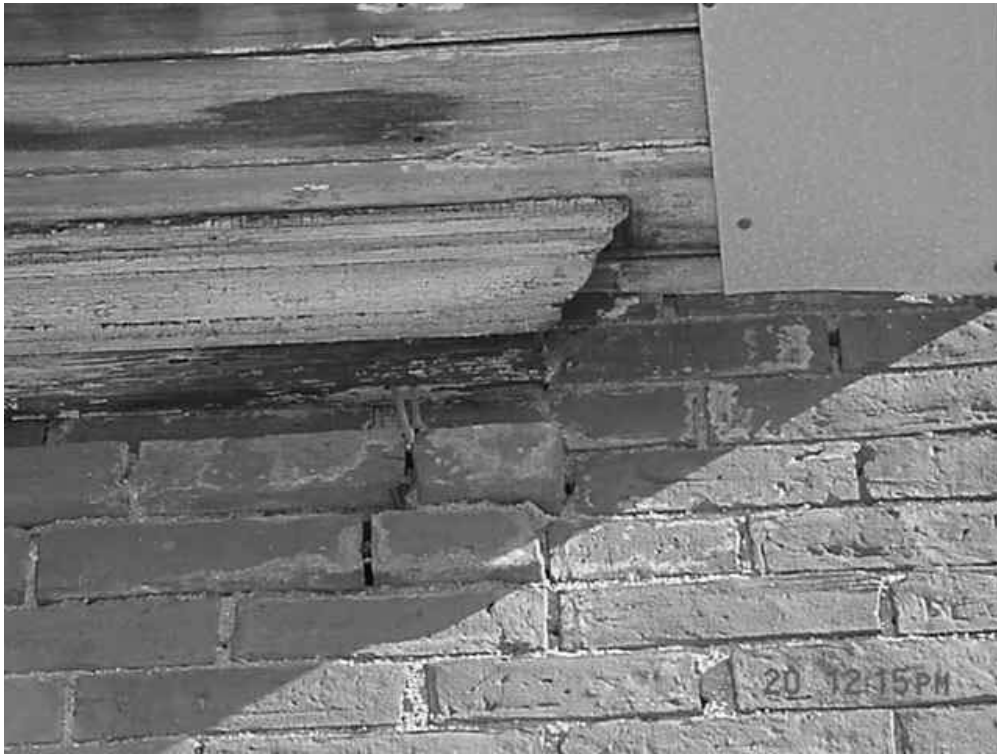
Picture 13

Another means for water penetration into the building is through the building envelope. Missing/damaged mortar around brickwork on the exterior of the building was observed in numerous areas (Pictures 13 through 16). This damage is particularly noticeable along the base of the building where water splashes against exterior walls because the gutter and downspout systems have been removed (Pictures 17 through 20).

Water Damaged Wood and Missing Damaged Mortar near Roof of Patrol Room Entrance

10. Continue to work with roofing contractor to make repairs as needed to prevent water penetration. Particular attention should be made to the exterior roof/flashing outside the patrol room shown in Pictures 13 and 18.

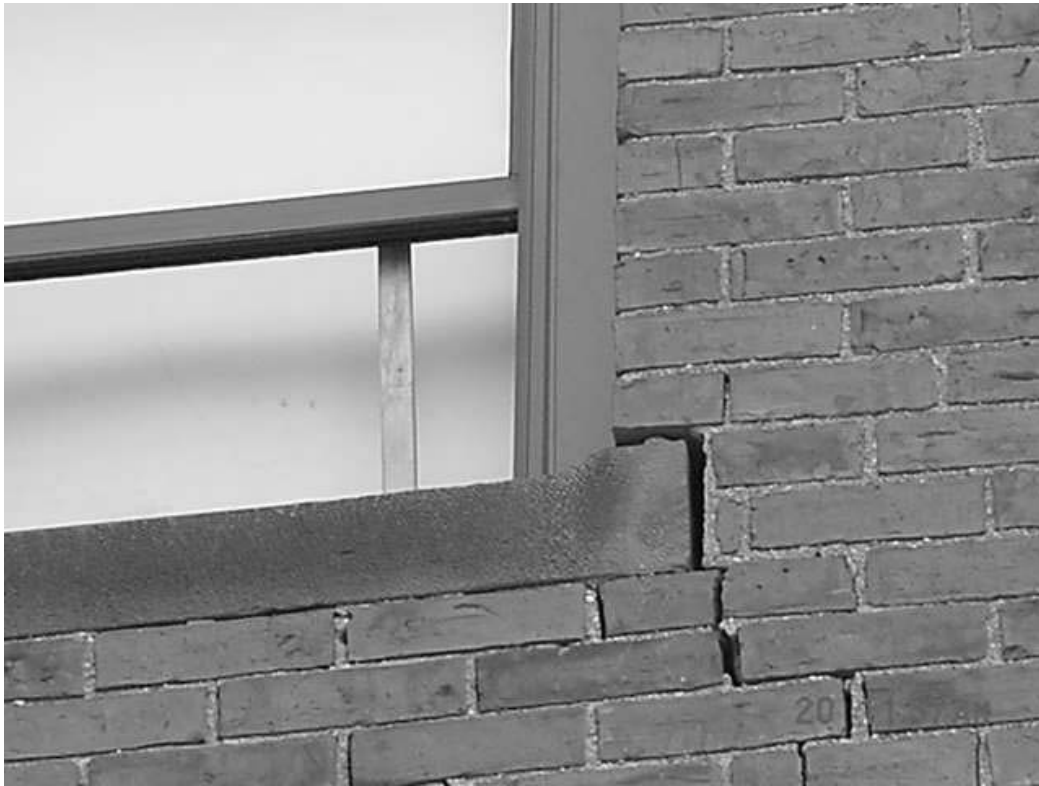
Picture 14

Missing Damaged Mortar near Second Floor Bunkroom Window

12. Contact a masonry firm or general contractor to repair holes/breaches in exterior walls to prevent water penetration, drafts and pest entry.
13. Clean exhaust and return vents periodically to avoid the build-up of excessive dust.

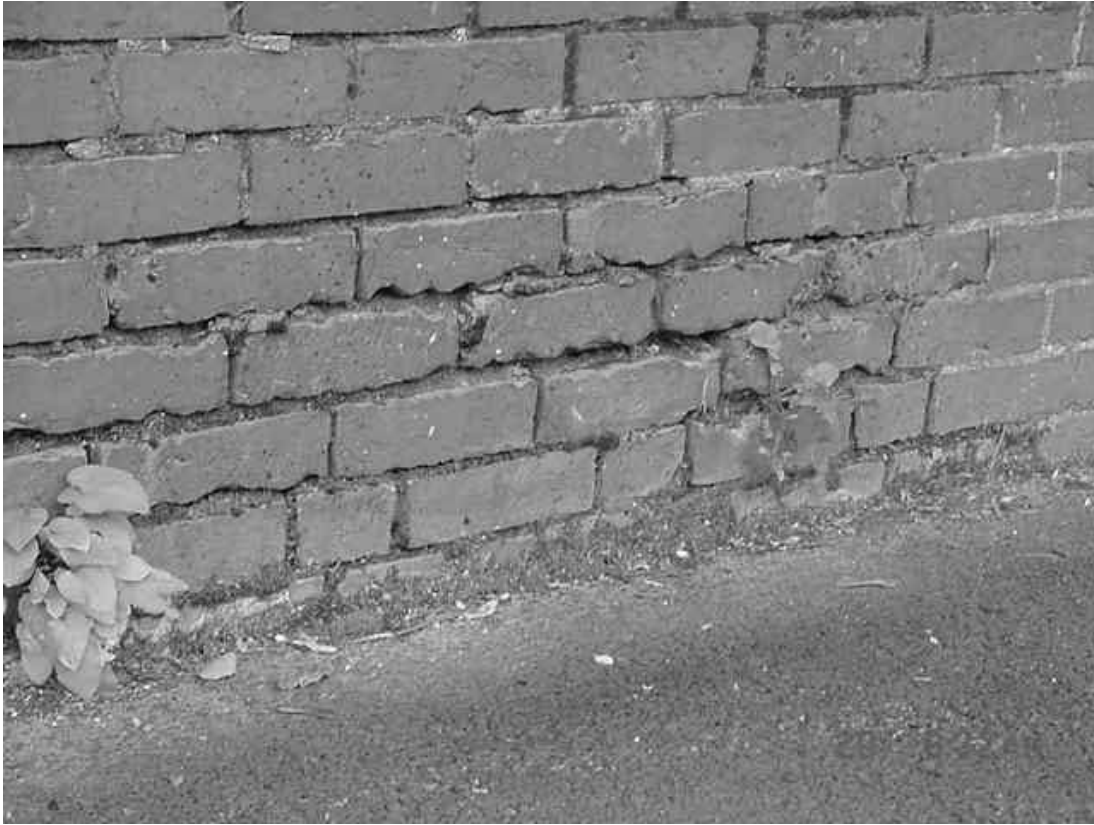
Picture 15

Heavy Moss Growth and Missing Damaged Mortar at Base of Building

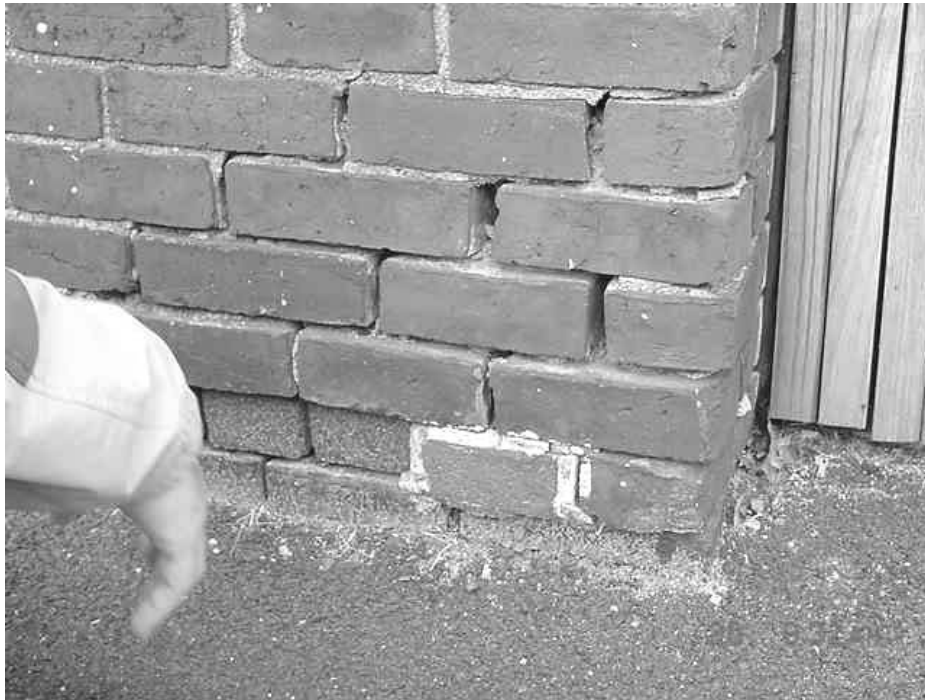
Picture 16

Missing Damage Mortar around Brick at Base of Building

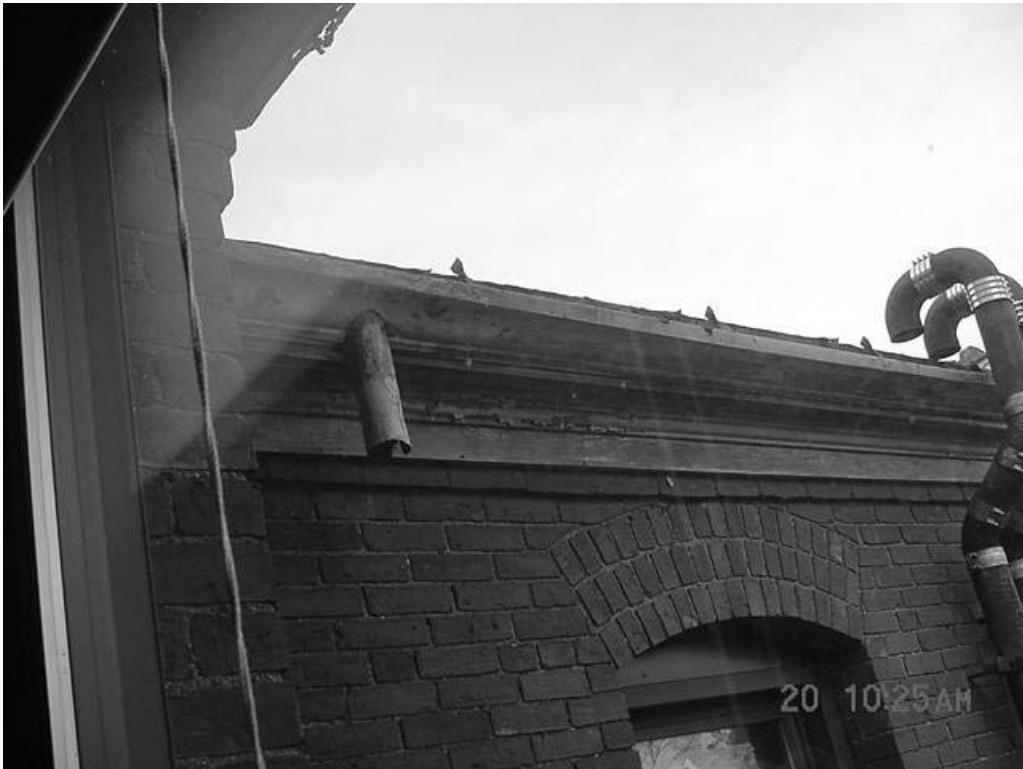
Picture 17

Missing Downspout

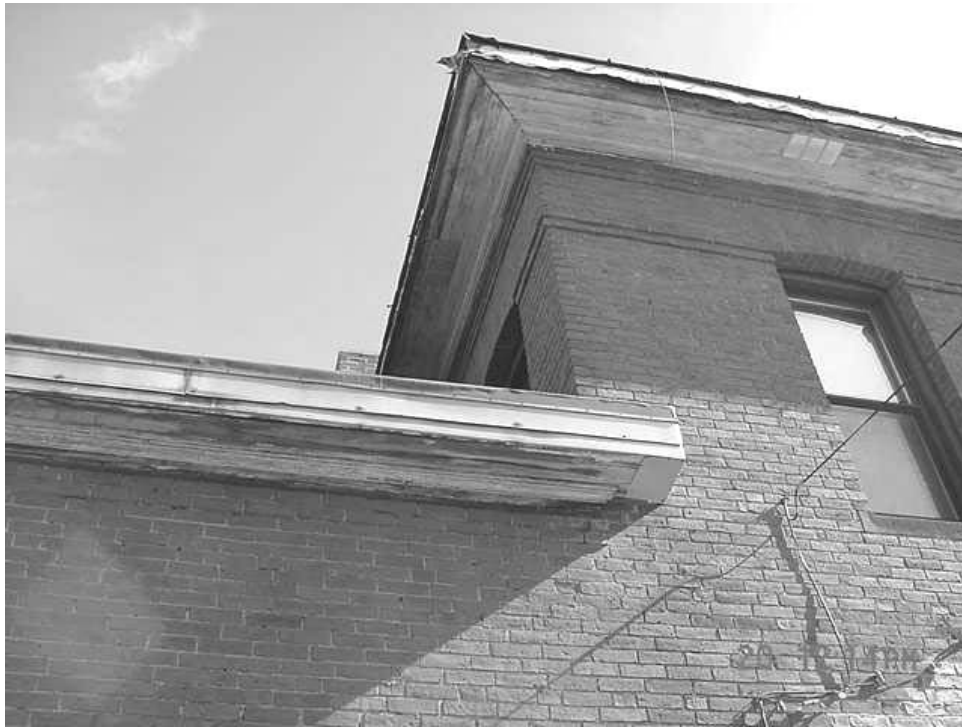
Picture 18

Sections of Roof over Patrol Room With no Gutters/Downspouts, Note Rotted Wood and Missing/Damaged Mortar (also shown in Picture 13)

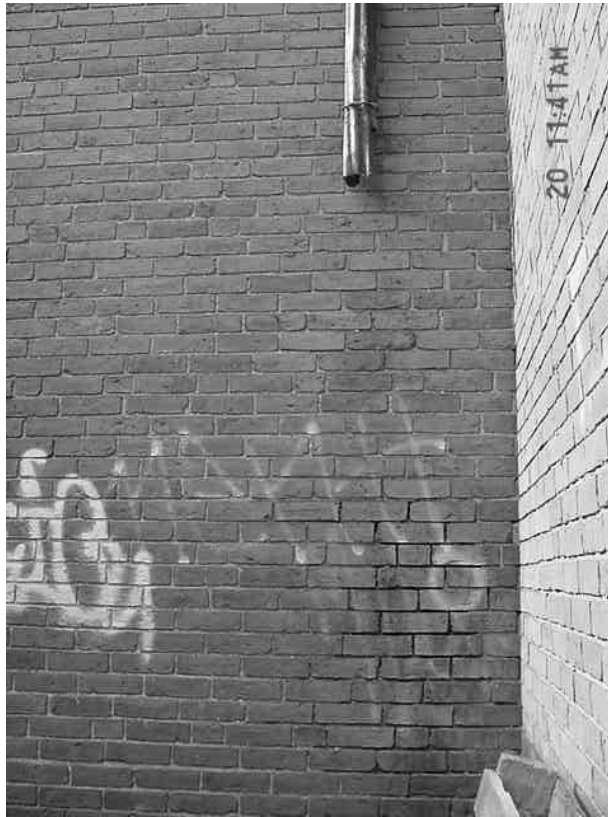
Picture 19

Missing Downspout, Note Water Damage/Staining to Wall

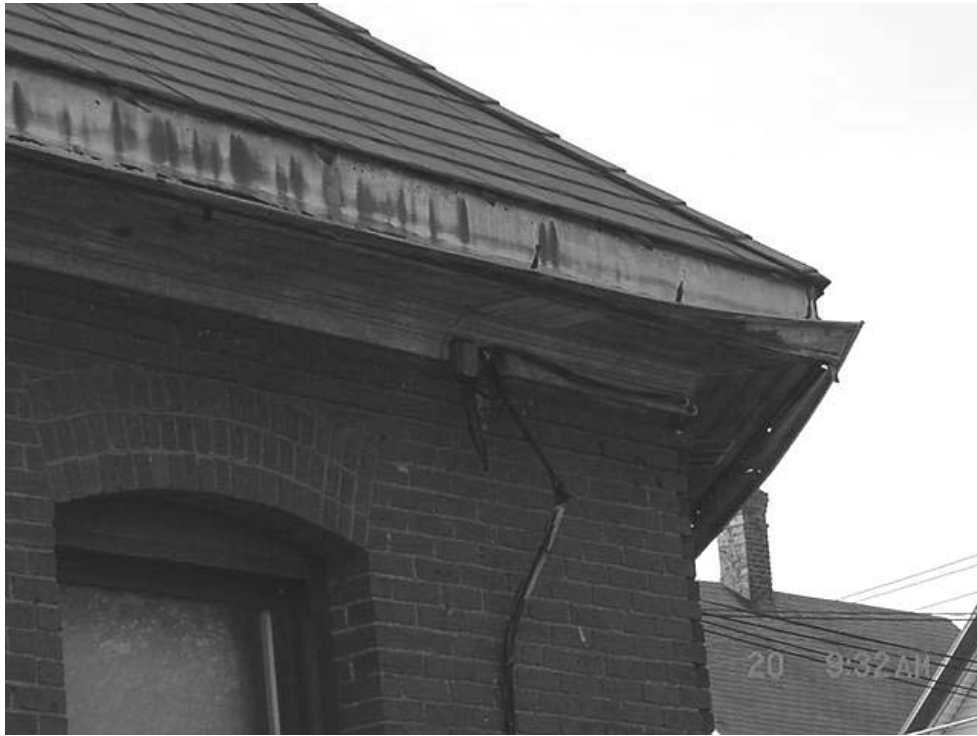
Picture 20

Sections of Roof With no Gutters/Downspouts

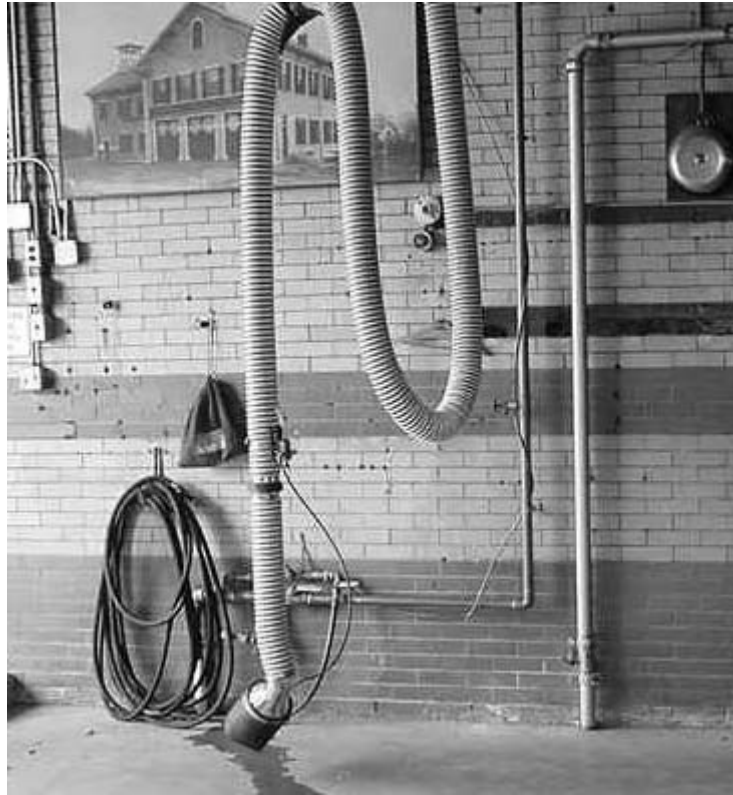
Picture 21

Local Exhaust System With Cuff That Attaches to Tailpipe

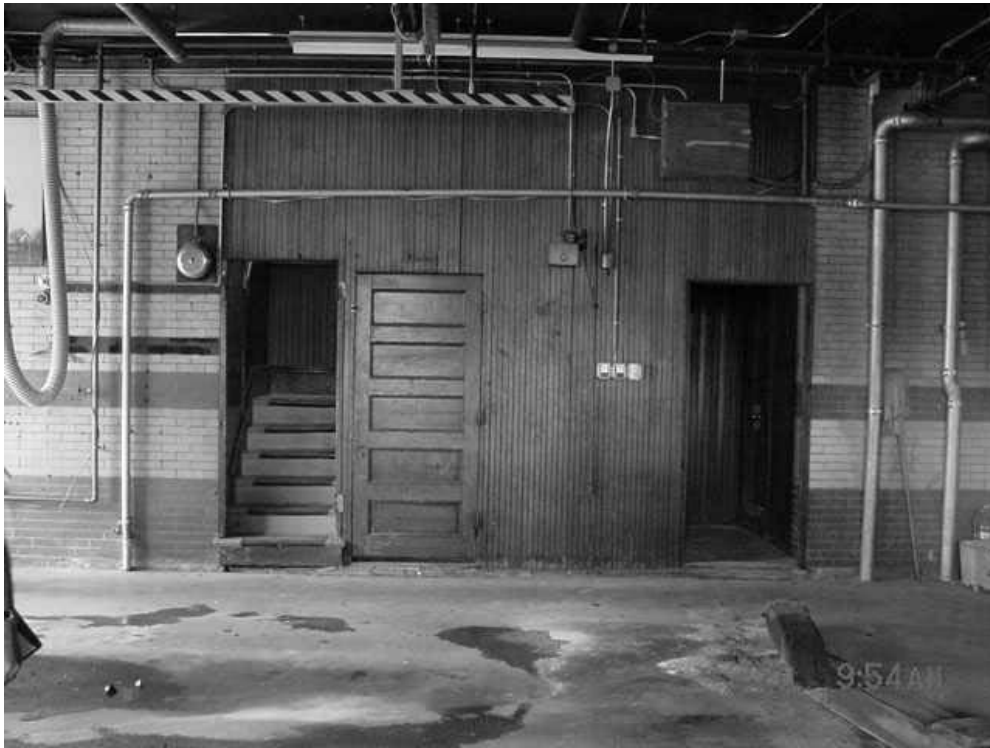
Picture 22

Stairwell off the Engine Bay With no Door

1. Install doors at the base of the stairwell in the engine bay. Ensure doors around engine bays and at the top of stairwell fit completely flush with threshold. Seal doors on all sides with foam tape, and/or weather-stripping. Consider installing weather-stripping/door sweeps on both sides of doors with access to the engine bay to provide a dual barrier. Ensure tightness of doors by monitoring for light penetration and drafts around doorframes.

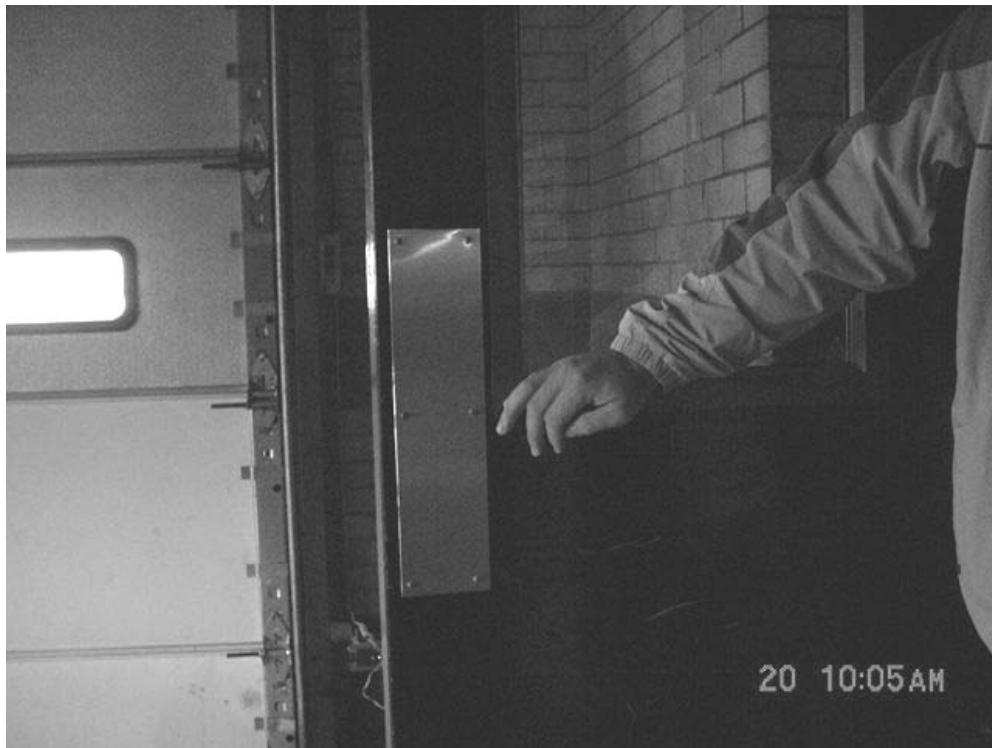
Picture 24

Patrol Room Door (Interior Side)

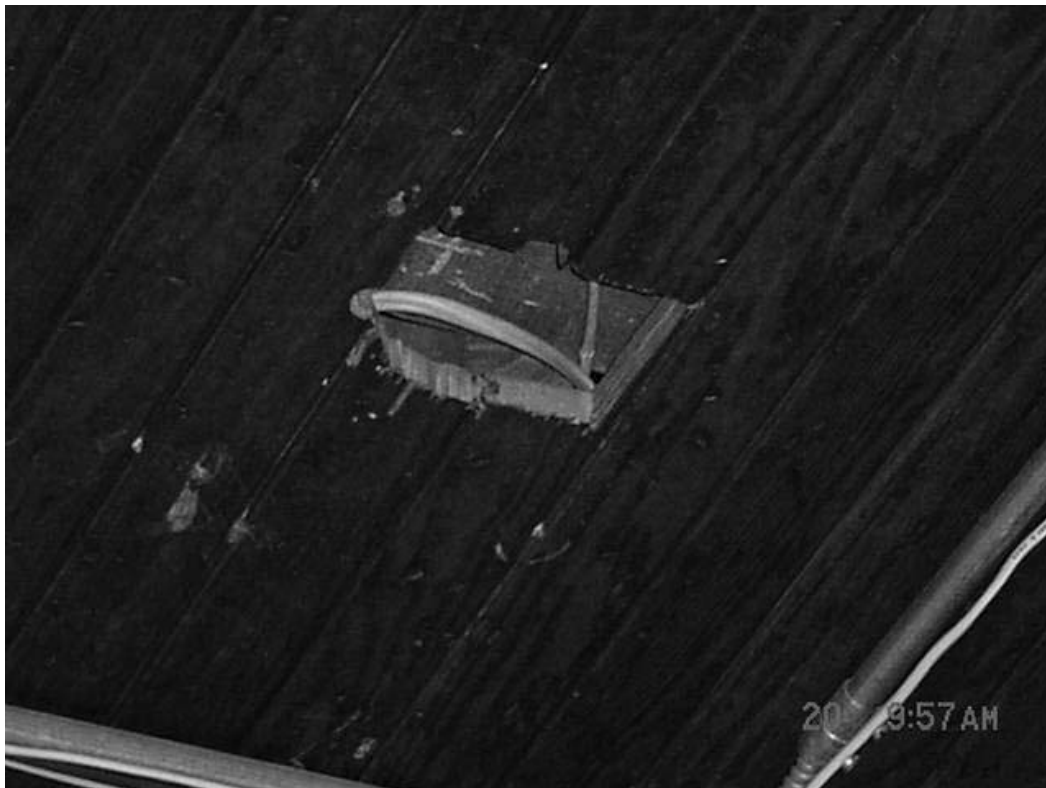
Picture 25

Hole in Engine Bay Ceiling

5. Ensure utility holes are properly sealed in both the engine bay and their terminus to eliminate pollutant paths of migration.
6. Work with Malden City officials to develop a preventative maintenance program for all HVAC equipment department wide, including local exhaust systems for engine bays.

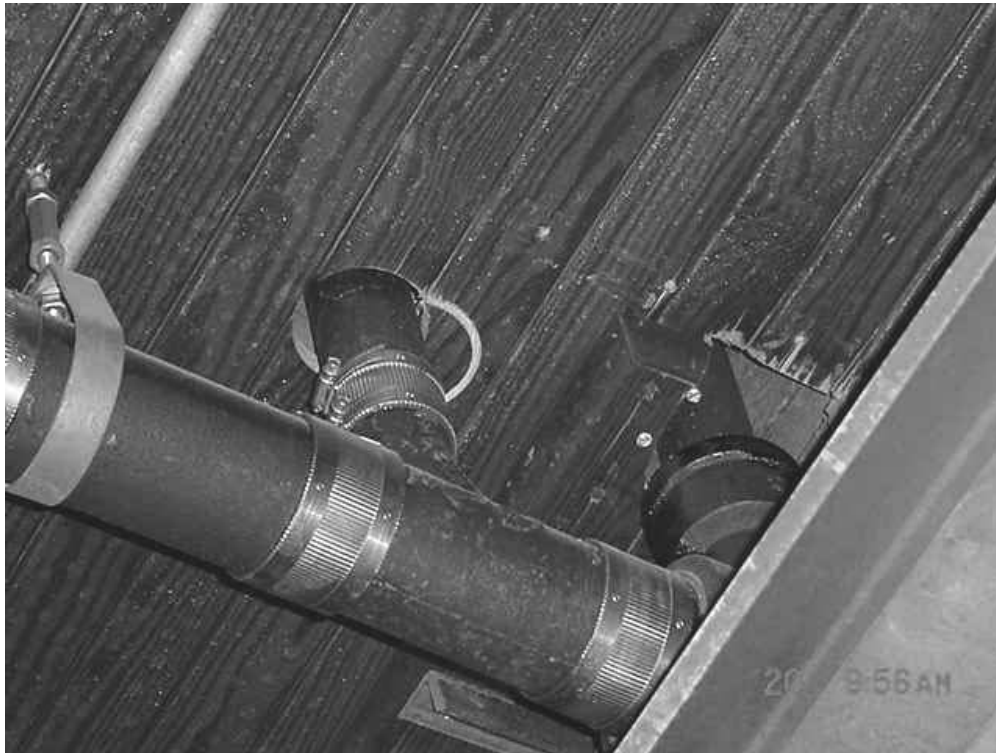
Picture 26

Utility Holes in Engine Bay Ceiling

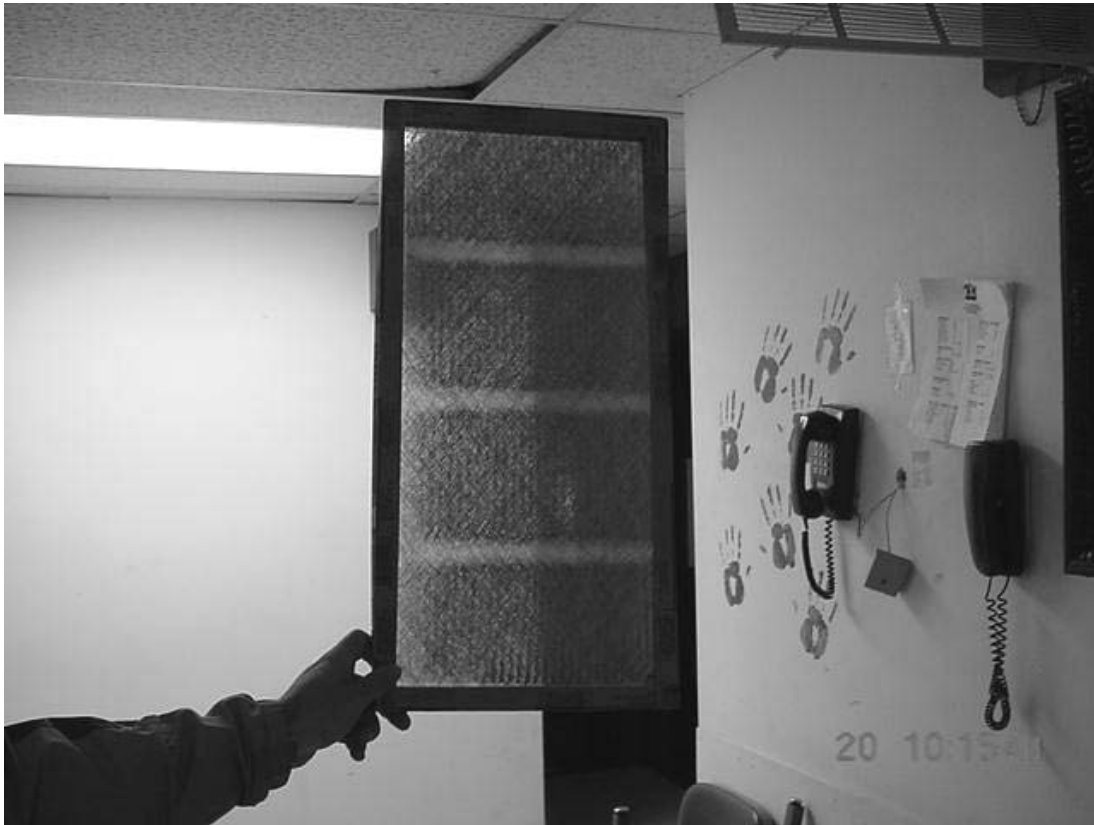
Picture 27

MFD staff could not identify the last filter change or preventative maintenance done on the HVAC equipment. MDPH staff inspected HVAC filters, which are located in the ceiling-mounted return vents. The filters were of a type that provides minimal filtration and were occluded with dust and debris (Picture 27). In order to decrease aerosolized particulates, higher efficiency, disposable filters can be installed. The dust spot efficiency is the ability of a filter to remove particulates of a certain diameter from air passing through the filter. Filters that have been determined by ASHRAE to meet its standard for a dust spot efficiency of a minimum of 40 percent would be sufficient to reduce airborne particulates

Dust Occluded Filter Installed in Ceiling-Mounted Return Vent

7. Change filters for HVAC equipment as per the manufacturer's instructions or more frequently if needed. Consider upgrading to higher efficiency pleated filters.

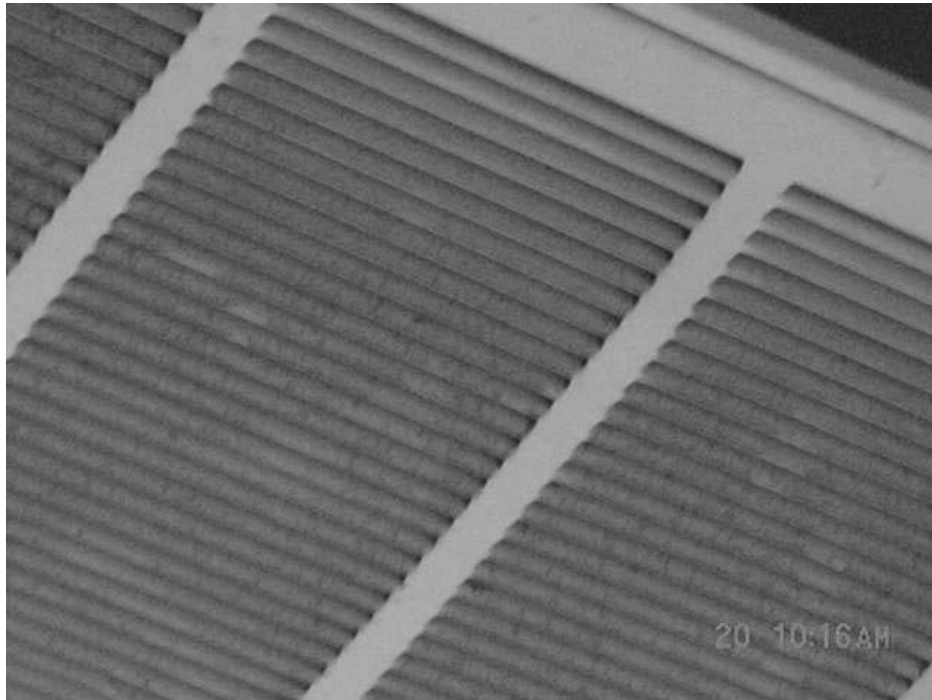
Picture 28

A number of exhaust and return vents in common areas and in restrooms had accumulated dust (Picture 28). If exhaust vents are not functioning, backdrafting can occur, which can re-aerosolize dust particles. In addition, these materials can accumulate on flat surfaces (e.g., desktops, shelving and carpets) in occupied areas and subsequently be re-aerosolized, causing further irritation.

Dust Accumulation on Return Vent in Second Floor Hallway

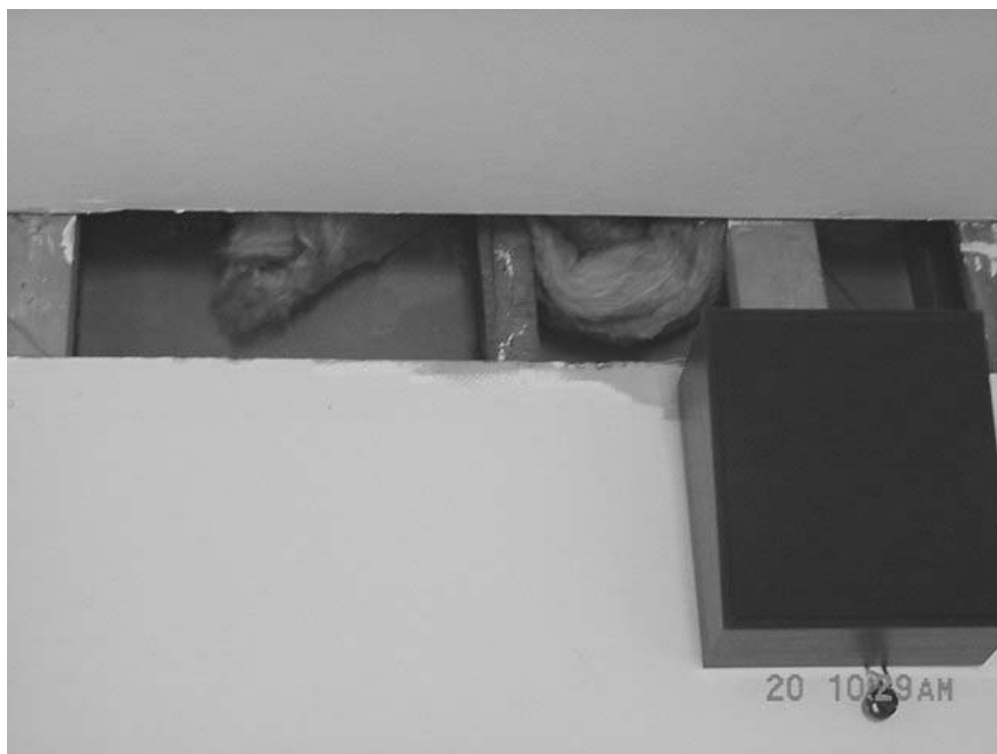
Picture 29

Finally, exposed fiberglass insulation was observed in the weight room (Pictures 29). Fiberglass insulation can be a source of skin, eye and respiratory irritation to sensitive individuals.

Exposed Fiberglass Insulation in Weight Room

14. Make repairs to walls in weight room to prevent exposure to fiberglass insulation.
15. For further building-wide evaluations and advice on maintaining public buildings, see the resource manual and other related indoor air quality documents located on the MDPH's website at <http://www.state.ma.us/dph/beha/iaq/iaqhome.htm>.

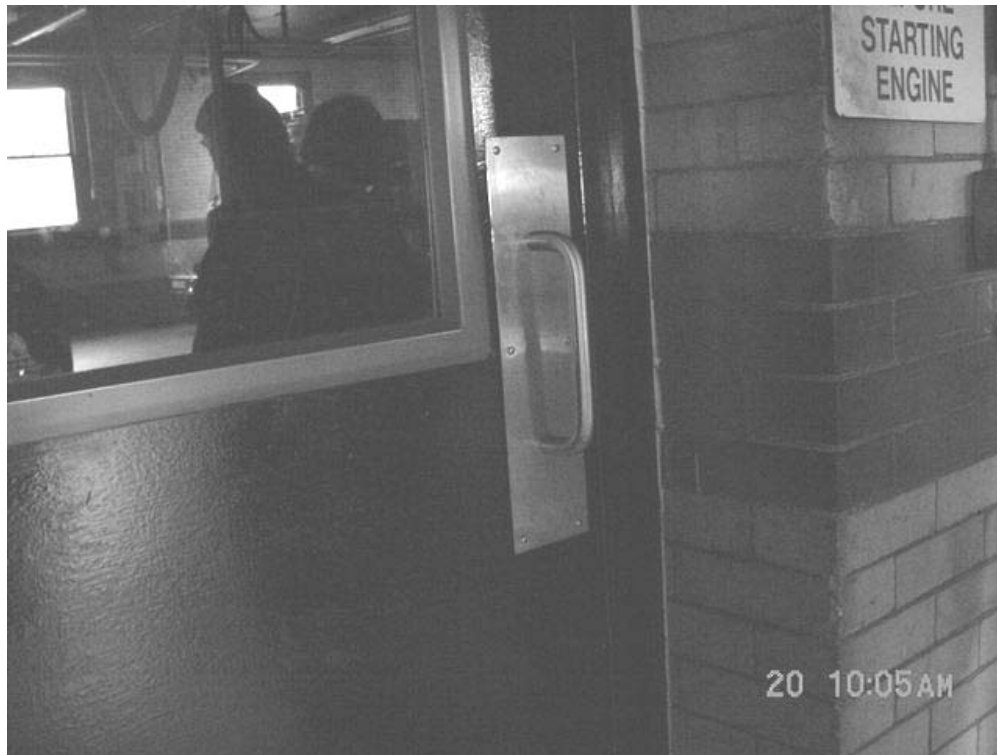
Picture 30

Handle Installed on Exterior Side of Patrol Room Door

2. Install handle on the interior side of patrol room door (Picture 30).
3. Install automatic closure hardware on stairwell doors (Picture 31).
4. Consider removing fire pole and sealing access hole. If not removed, install clamshell-type closures around firepole to prevent pollutant pathways.
